OMC STRINGER STERNDRIVE TILT SYSTEM INTRODUCTION:

The purpose of this guide is to help the owners of OMC Stringer sterndrives built from 1963 to 1984 better understand the theory of operation and repair of the standard equipment, electro-mechanical power tilt system common to all of these OMC-built Stringer sterndrives.

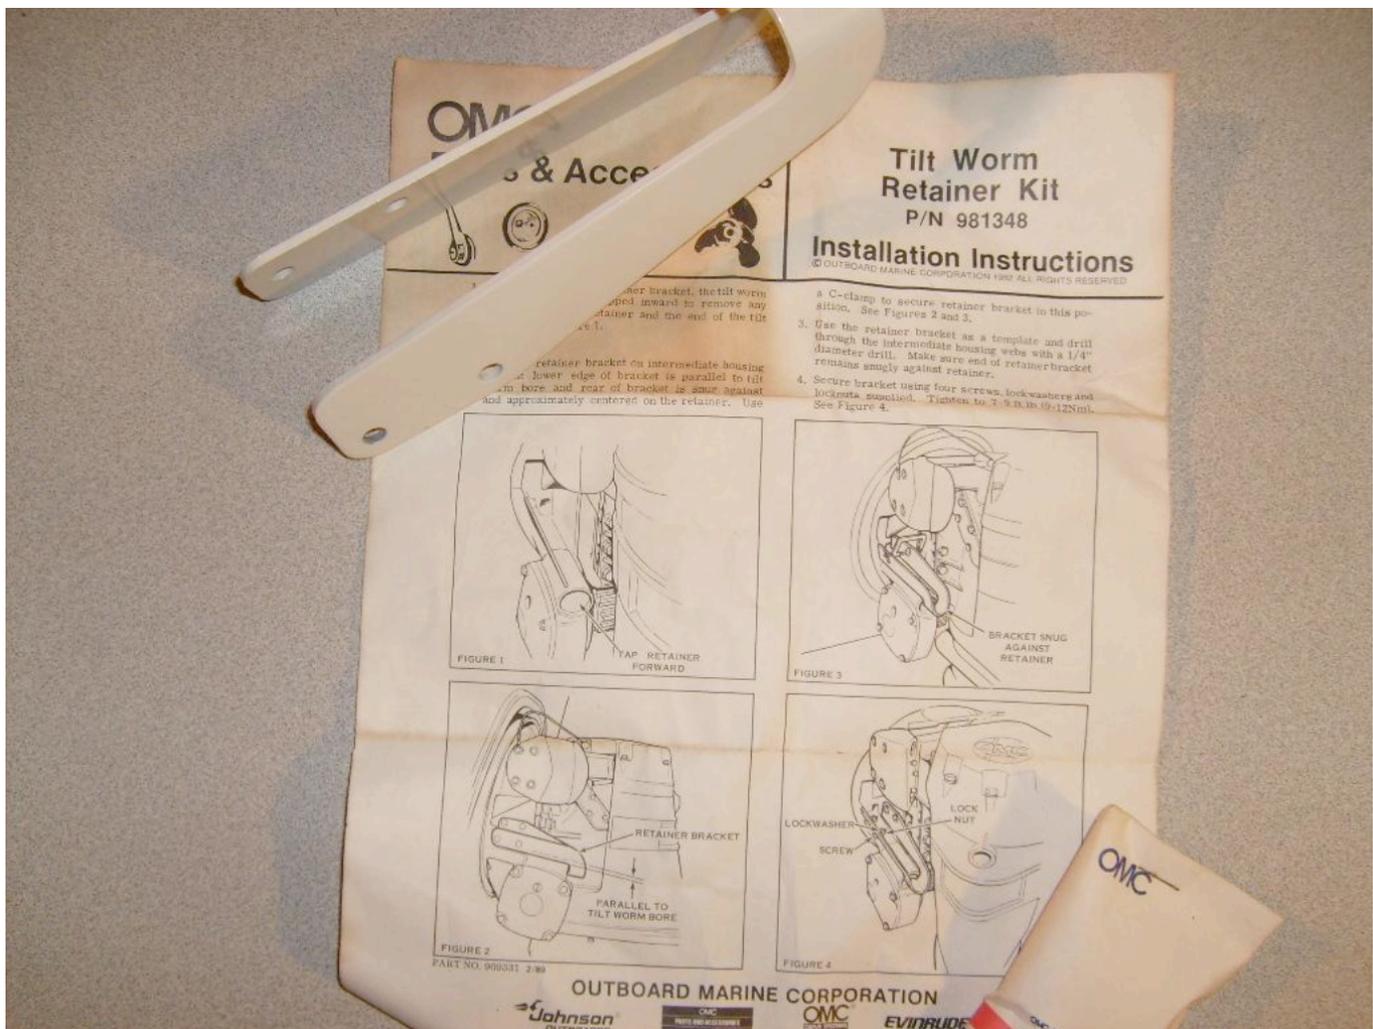
OMC Tilt Worm Retainer Kit

OMC Part Number 981348

The retaining kit prevents the worm gear shaft from being lost into the water, should the retaining circular snap clip become corroded. Unfortunately, if the circular snap clip retaining groove or shaft is no longer able to retain the worm gear shaft, it becomes necessary to replace the entire intermediate housing. This kit can avoid costly intermediate housing replacement under these circumstances. While this kit is no longer available, retaining kits do show up occasionally on eBay.
